Non-destructive thickness measurement of thermal barrier coatings using terahertz radiation

Luis Isern¹ · Andrew J. Waddie² · Christine Chalk¹ · Andrew J. Moore² · John R. Nicholls¹

Abstract

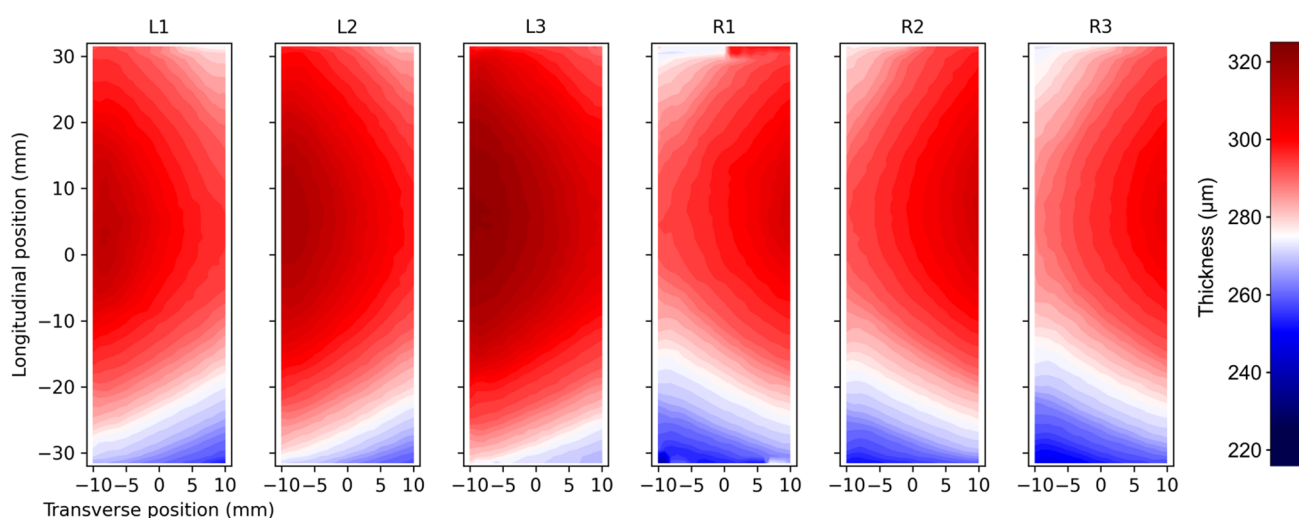
Fig. 7 Thickness maps for all samples constructed from THz reflectivity measurements. Each sample (R1, R2, R3 and L1, L2, L3) is labelled above the corresponding thickness map

Applying the previously obtained refractive index of 3.977, the reflectivity maps can be converted into thickness maps as shown in Fig. 7. These maps reveal a strong handedness of the samples, with all R samples having the local maximum on the right-hand side, whereas all L samples having the local maximum on the left-hand side. This is explained by the direction of rotation of the samples, described in Fig. 1, and their orientation on the holder, perpendicular to the Fig. 1 schematic and considering the sample “top” as closer to the point of view of the reader. The leading edge (i.e. the foremost edge on the direction of rotation) of L samples is the left-hand side, whereas for R samples is the right-hand side. Therefore, the local-maximum side is the leading-edge, as expected. Longitudinally, this local maximum occurs at approximately $y = +5$ mm as noted previously, which corresponds to the small vertical offset of the ceramic ingot with respect to the rotating sample holders. The minimum thickness is located on the bottom corner opposite to the maximum (trailing-edge of the rotation), and the thickness variation across each sample is ~40 μm. Samples coated on the left-hand side holder have a greater thickness across their whole surface, which is expected due to the asymmetric position of the two substrate holders in the chamber with the left being closer

to the ingot (Fig. 1). There seem to be small thickness variations within the L samples, as well as within the R samples, with L3 and R2 being the thickest of the groups. This is likely a consequence of the holders not being

perfectly horizontal, so one of the faces of the triangle is closer to the ingot. In summary, the thickness distribution on the samples corresponds well with the distance

to the ingot and the direction of rotation, as predicted by a “point source” evaporation model.

Finally, the bondcoat of four samples (R1 and L1) had an intentional defect around the central area, as described in the methodology. It is noted that the thickness maps of those samples (Fig. 7) are not influenced by the presence of these macro-defects. The THz radiation, at the current frequencies used, is reflected by the metallic nature of the bondcoat and therefore does not see these bondcoat defects. Therefore, the defect induced in the bondcoat (which results in aluminium deficiency) does not change its metallic nature and hence does not affect its reflectivity. The only effect that THz radiation could detect is changes in the thermally grown oxide (TGO). However, the TGO thickness of all samples examined is too small (< 2 μm) after this short time of aging to show any effect on the thickness maps.
